WL-TR-91-4032
DOT/FAA/CT-91/23
VOL II, Part 2

COMPOSITE FAILURE ANALYSIS HANDBOOK
VOL II - TECHNICAL HANDBOOK
PART 2 - ATLAS OF FRACTOGRAPHS

R.J. Kar
Northrop Corporation
One Northrop Avenue
Hawthorne, California 90250-3277

February 1992

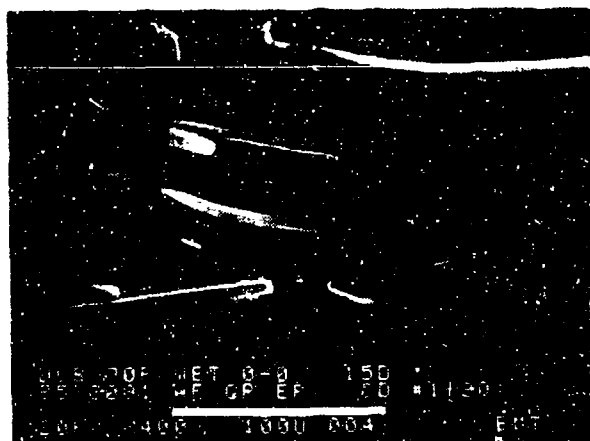
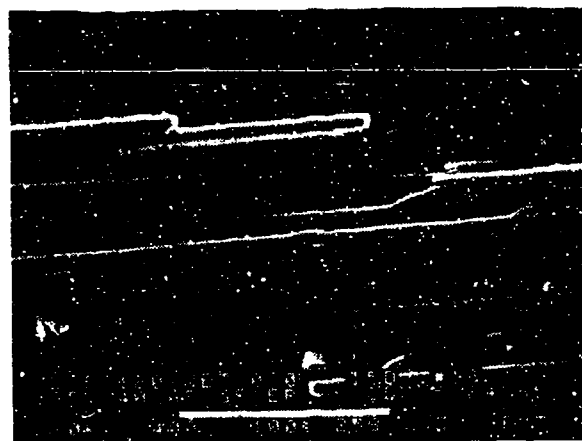
Figure 2-11. SEM Photographs of Interlaminar Mode I Tension, 0/0 Fracture, 70 and 180 F/Wet

Fracture type	Interlaminar mode I tension
Ply layup	[0] 24
Test type	DCB
• Test conditions	Wet
• Fracture between	0/0 plies
Material	Hercules 3501-6/177°C cure AS4 fibers

←
Mechanically Induced crack direction

70°F, wet

180°F, wet

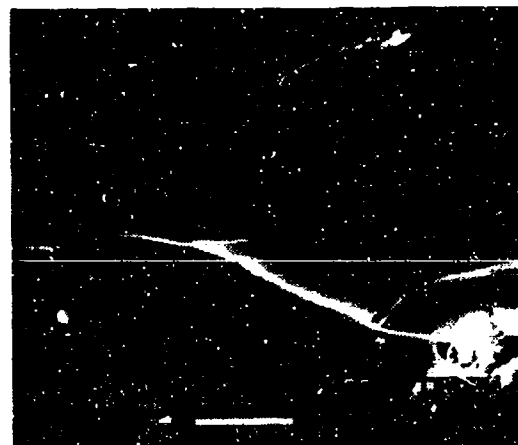
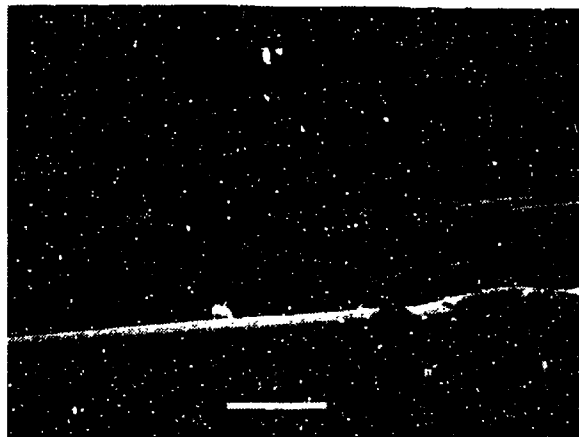
Figure 2-12. SEM Photographs of Interlaminar Mode I Tension, 0/0 Fracture, 70 F/Wet, 180 F/Dry, and 180 F/Wet

Fracture type	Interlaminar mode I tension
Ply layup	[0] 24
Test type	DCB
• Test conditions	Dry/wet
• Fracture between	0/0 plies
Material	Hercules 3501-6/177°C cure AS4 fibers

←
Mechanically Induced crack direction

70°F, wet

180°F, dry

180°F, wet

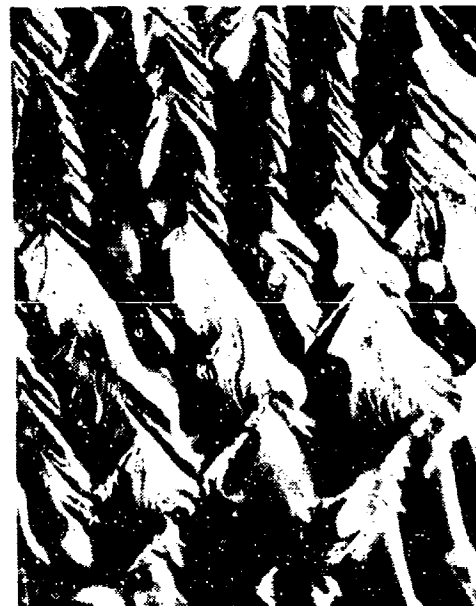
Figure 2-13. Photographs of Interlaminar Mode I Tension, +45/-45 Fracture, 70 F/Dry

Fracture type	Interlaminar mode I tension
Ply layup	[+45, -45] 12S
Test type	DCB
• Test conditions	21°C dry
• Fracture between	+45/-45 plies
Material	Hercules 3501-6/177°C cure AS4 fibers

100X

400X

← Mechanically Induced crack direction

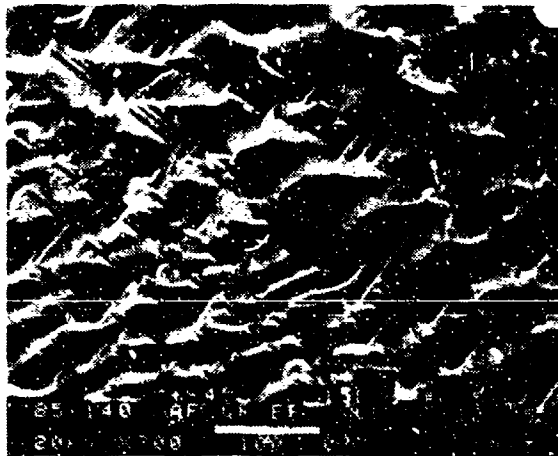
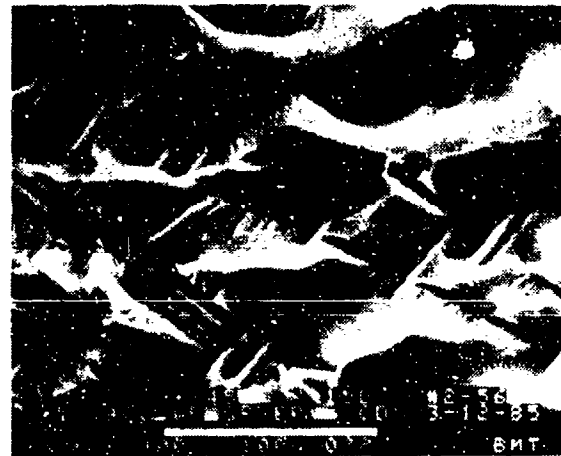
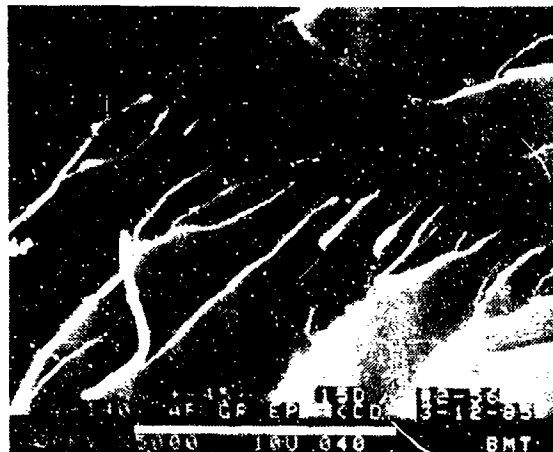
Figure 2-14. SEM Photographs of Interlaminar Mode I Tension, +45/-45 Fracture, 70 F/Dry

Fracture type	Interlaminar mode I tension
Ply layup	[+45, -45] 12S
Test type	DCB
• Test conditions	21°C dry
• Fracture between	+45/-45 plies
Material	Hercules 3501-6/177°C cure AS4 fibers

Legend:
 F Fiber matrix separation
 M Matrix fracture
 R River markings
 T Textured microflow

←
 Mechanically induced crack direction

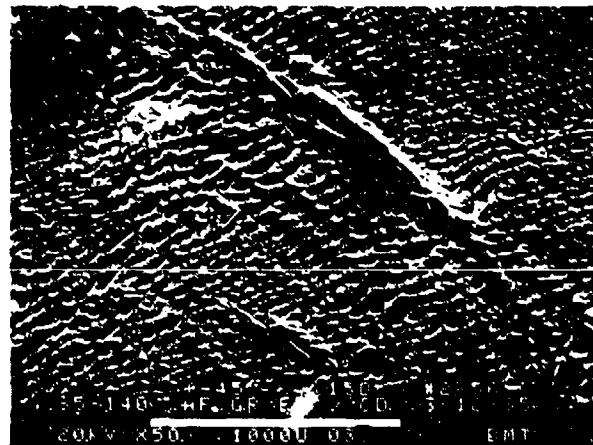
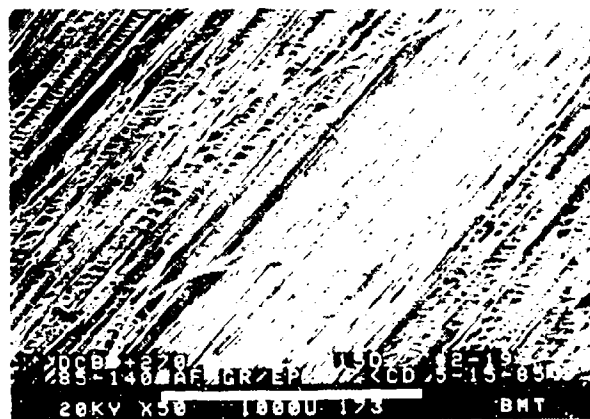
Figure 2-16. SEM Photographs of Interlaminar Mode I Tension, +45/-45 Fracture, -65, 70, and 270 F/Dry (50X)

Fracture type	Interlaminar mode I tension
Ply layup	[+45,-45] 12S
Test type	DCB
• Test conditions	Dry
• Fracture between	+45/-45 plies
Material	Hercules 3501-6/177°C cure AS4 fibers

Mechanically induced crack direction

-65°F, Dry

70°F, Dry

270°F, Dry

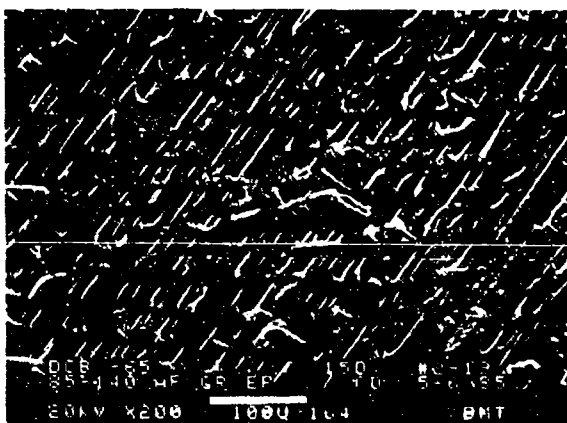
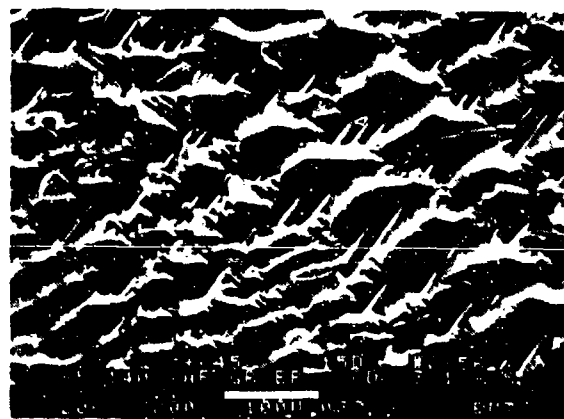
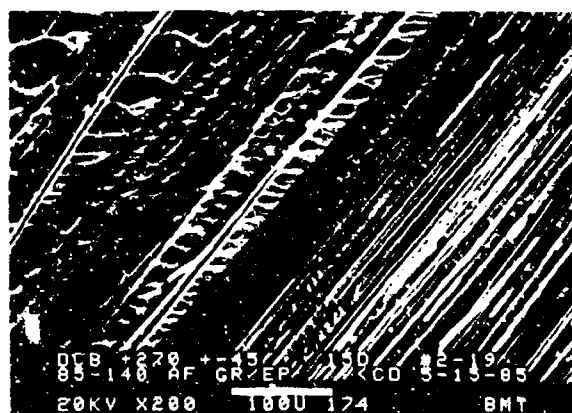
Figure 2-17. SEM Photographs of Interlaminar Mode I Tension, +45/-45 Fracture, -65, 70, and 270 F/Dry (200X)

Fracture type	Interlaminar mode I tension
Ply layup	[+45,-45] 12S
Test type	DCB
• Test conditions	Dry
• Fracture between	+45/-45 plies
Material	Hercules 3501-6/177°C cure AS4 fibers

Mechanically Induced crack direction

-65°F, Dry

70°F, Dry

270°F, Dry

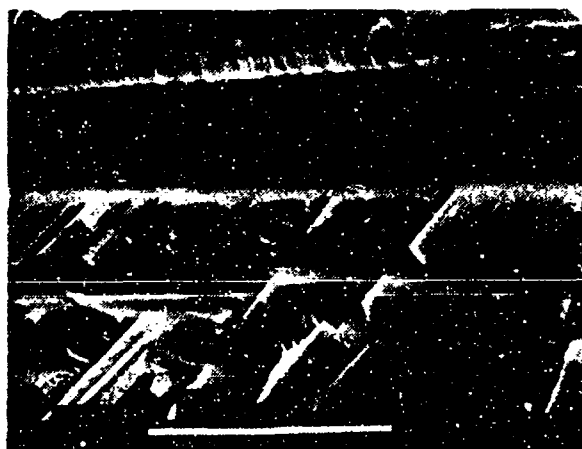
Figure 2-22. SEM Photographs of Interlaminar Mode I Tension, 0/45 Fracture, 70 F/Wet

Fracture type	Interlaminar mode I tension
Ply layup	[0.45] _{12S}
Test type	DCB
• Test conditions	Wet
• Fracture between	0/45 plies
Material	Hercules 3501-6/177°C cure AS4 fibers

- F Fiber matrix separation
- M Matrix fracture
- R River markings
- T Textured microflow

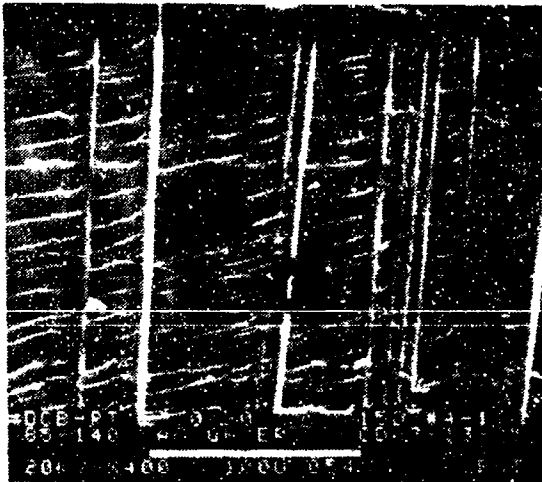
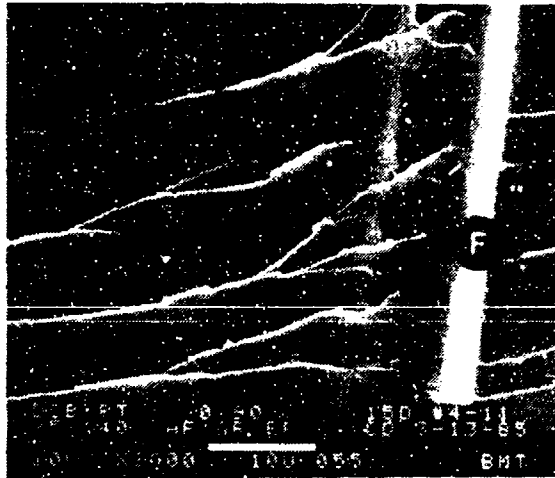
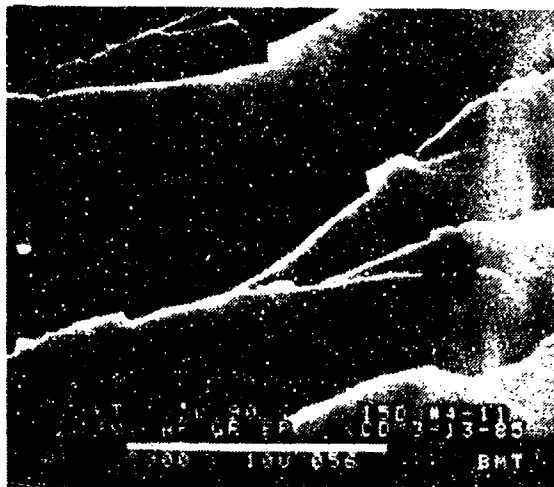
Figure 2-24. SEM Photographs of Interlaminar Mode I Tension, 0/90 Fracture, 70 F/Dry

Fracture type	Interlaminar mode I tension
Ply layup	[0, 90] _{12S}
Test type	DCB
• Test conditions	21°C, dry
• Fiber end fracture	
Material	Hercules 3501-6/177°C cure AS4 fibers

- F Fiber matrix separation
- M Matrix fracture
- R River markings
- T Textured microflow

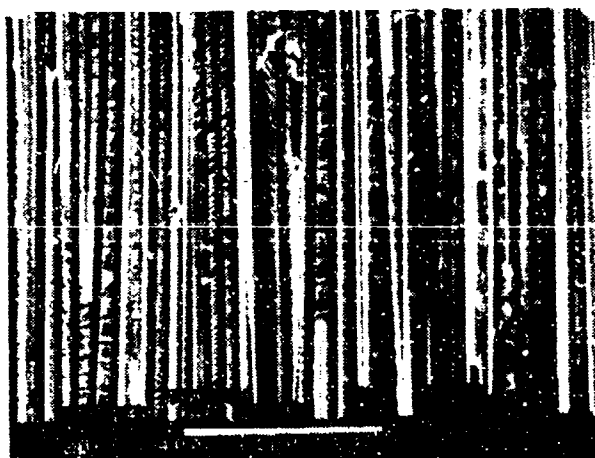
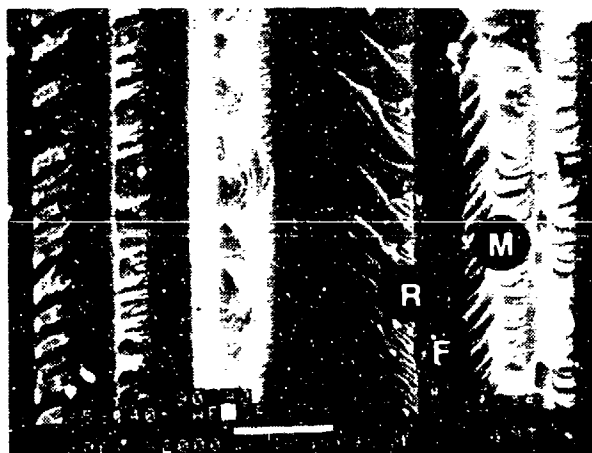
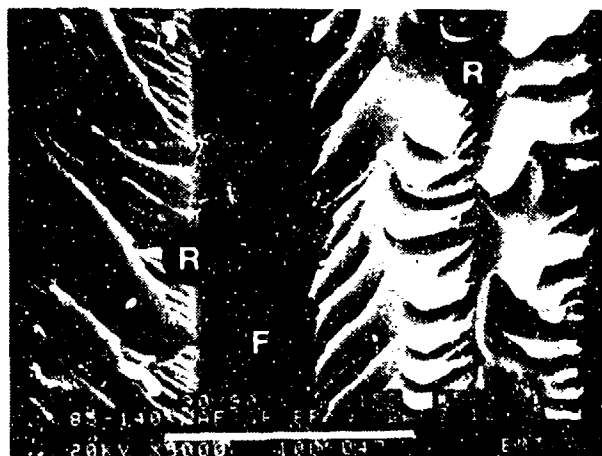
Figure 2-27. SEM Photographs of Interlaminar Mode I Tension, 90/90 Fracture, 70 F/Dry

Fracture type	Interlaminar mode I tension
Ply layup	[90]24
Test type	DCB
• Test conditions	21°C, dry
• Fracture between	0/90 plies
Material	Hercules 3501-6/177°C cure AS4 fibers

- F Fiber matrix separation
- M Matrix fracture
- R River markings

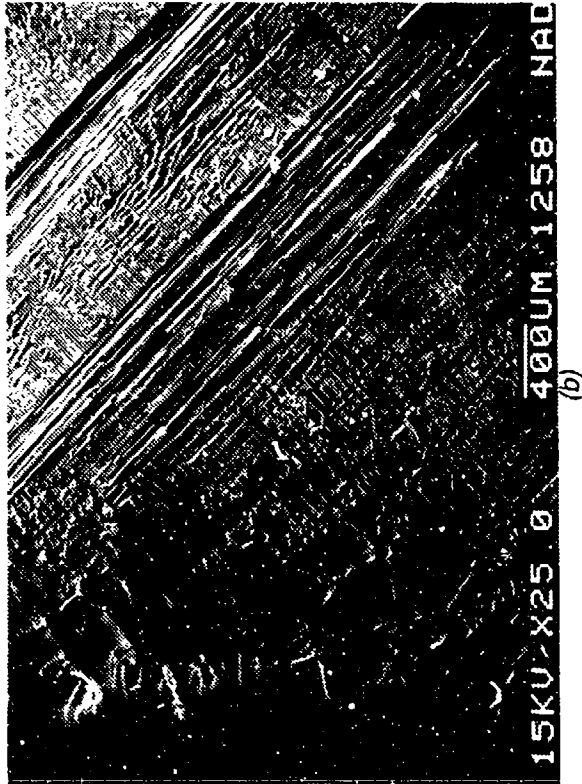
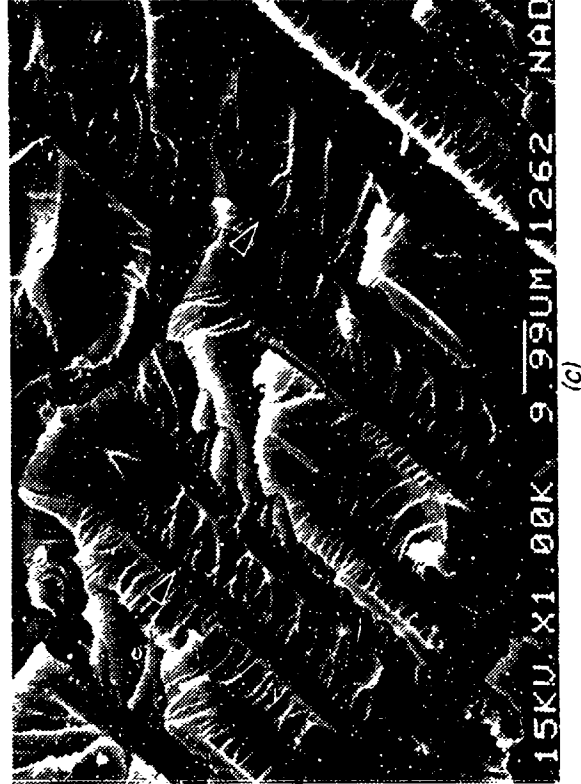
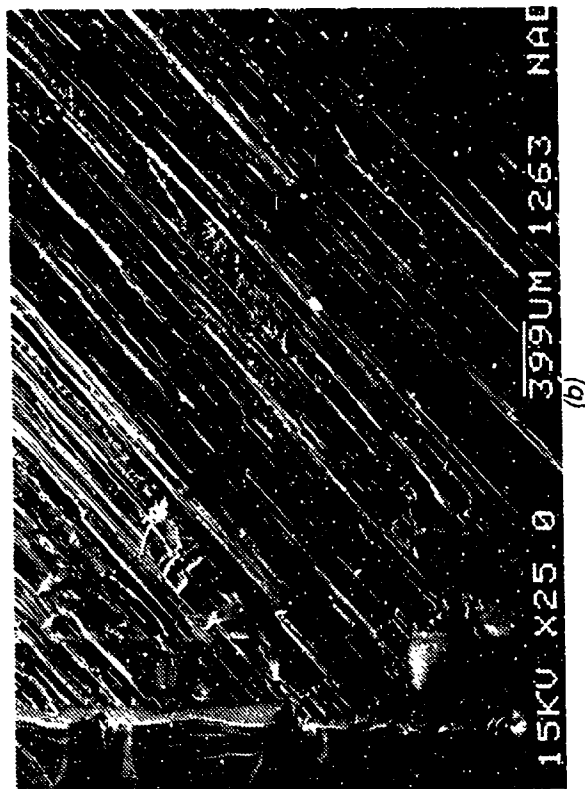
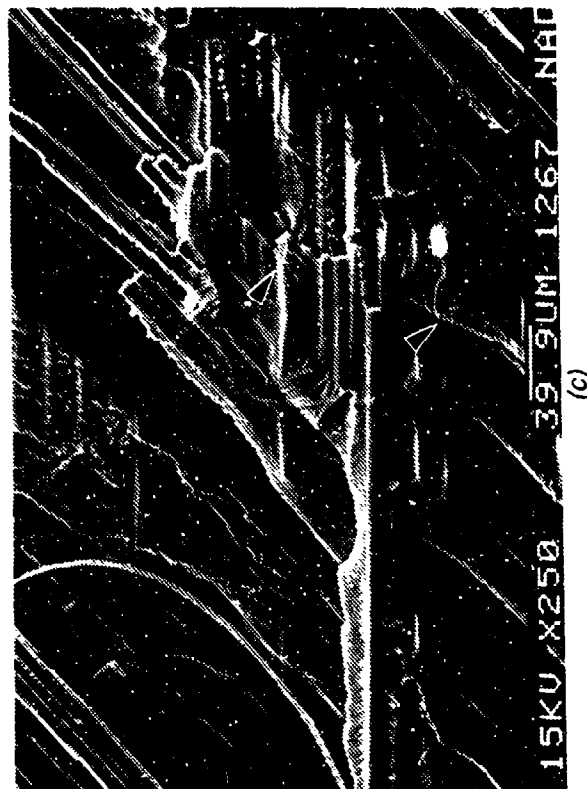
Optical photograph of the filament wound Grl/Ep laminate showing the three regions I, II, and III.

Figure 2-29. Optical and SEM Photographs of Mode I DCB Interlaminar Fracture in Filament Wound Grl/Ep - [+45/0/-45]_{4s}, Room Temperature Ambient
 (a) Macro photograph
 (b) Initiation in Precrack Region
 (c) River Patterns in Mode I Tension Fracture

CD = Crack propagation direction
 R = River patterns

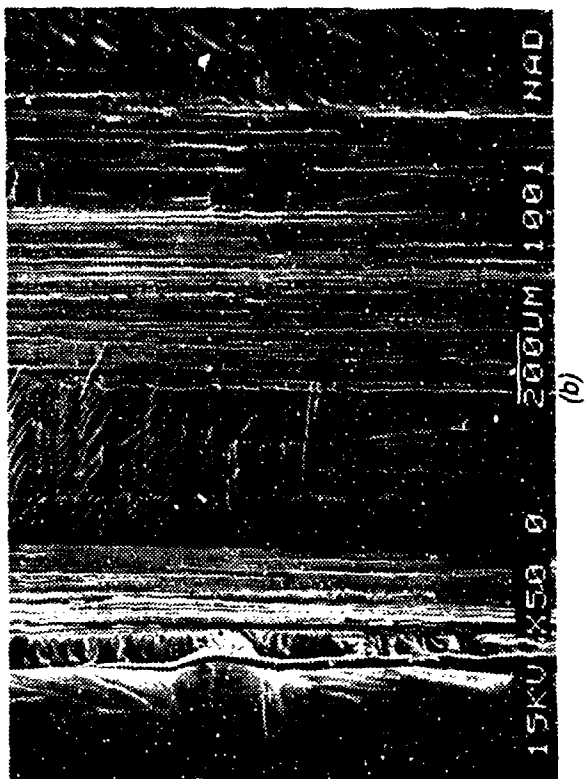
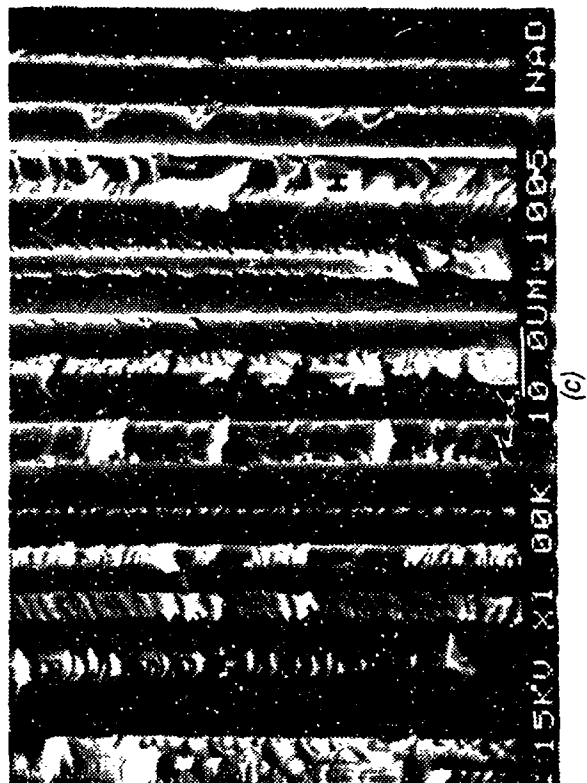
Figure 2-30. Optical and SEM Photographs of Mode I DCB Interlaminar Fracture in Filament Wound Gr/Ep - [0/90] 6S, Room Temperature Ambient
(a) Macro photograph
(b) Initiation in Precrack Region
(c) Local Hackles in 90 Degree Ply

CD = Crack-propagation direction
H = Hackles

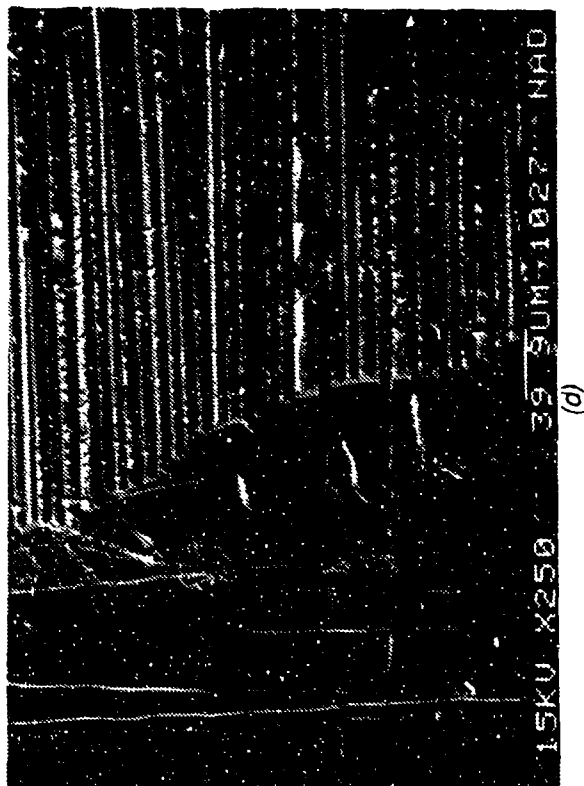
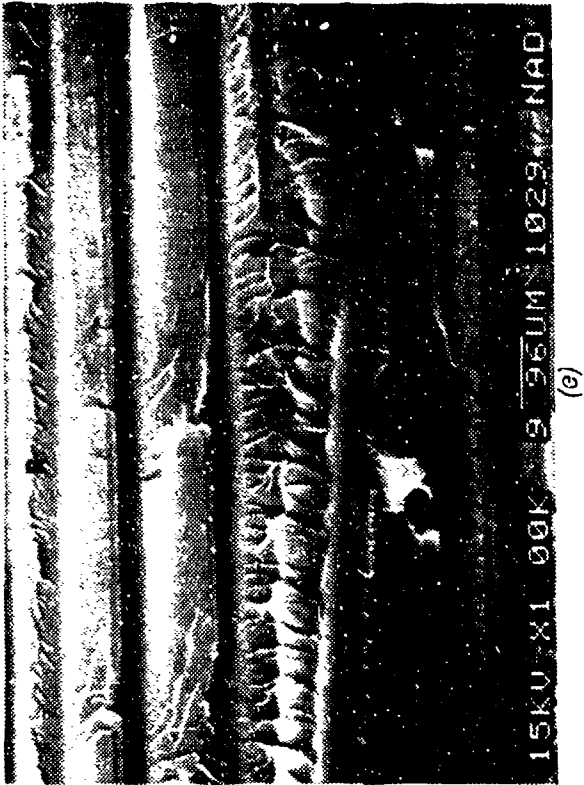
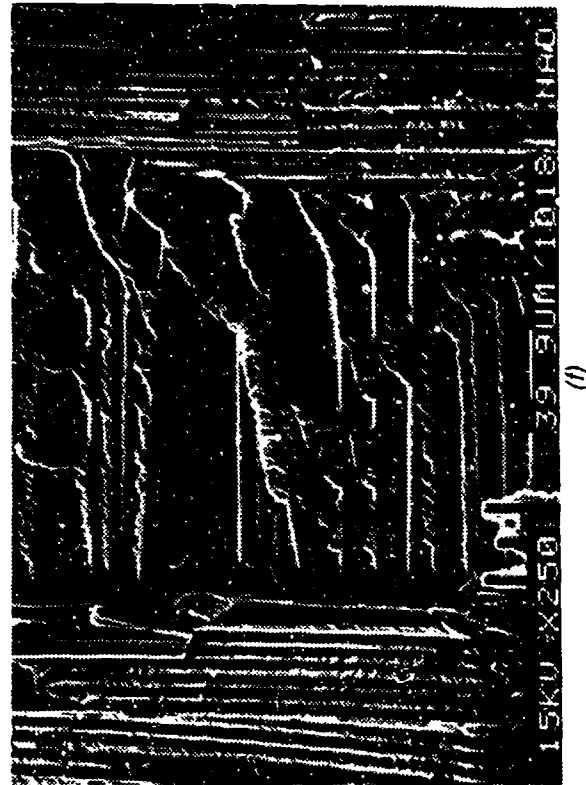
Figure 2-30. (Continued)
 (d) Precrack/Crack-Growth Interface
 (e) River Patterns in Epoxy
 (f) River Patterns in Epoxy Away From Interface
 CD = Crack-propagation direction
 R = River patterns

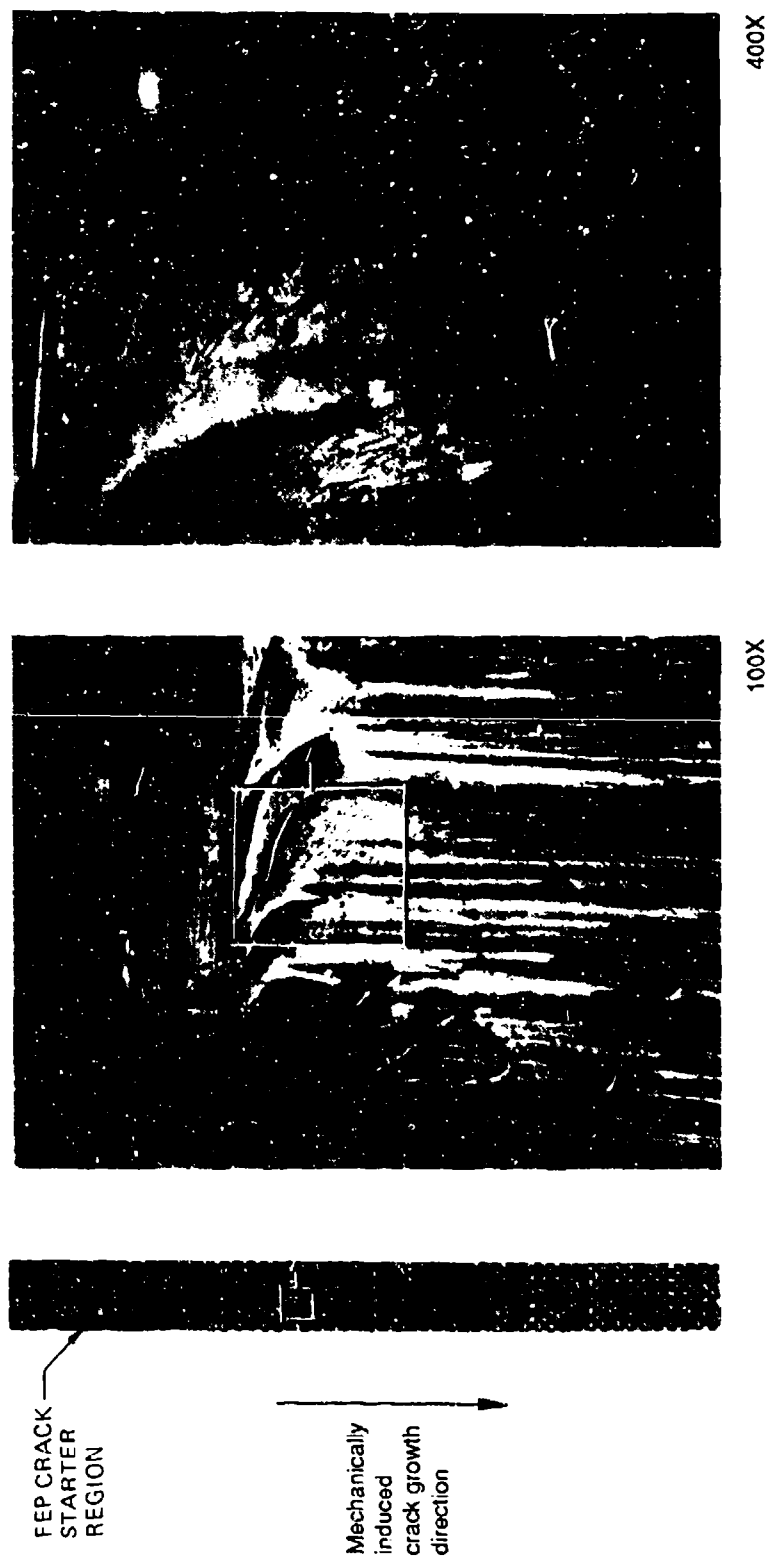
Figure 2-31. Optical Photomicrographs of Interlaminar Mode I Tension, Room Temperature, Fabric Fracture, $[0/90]_{6s}$

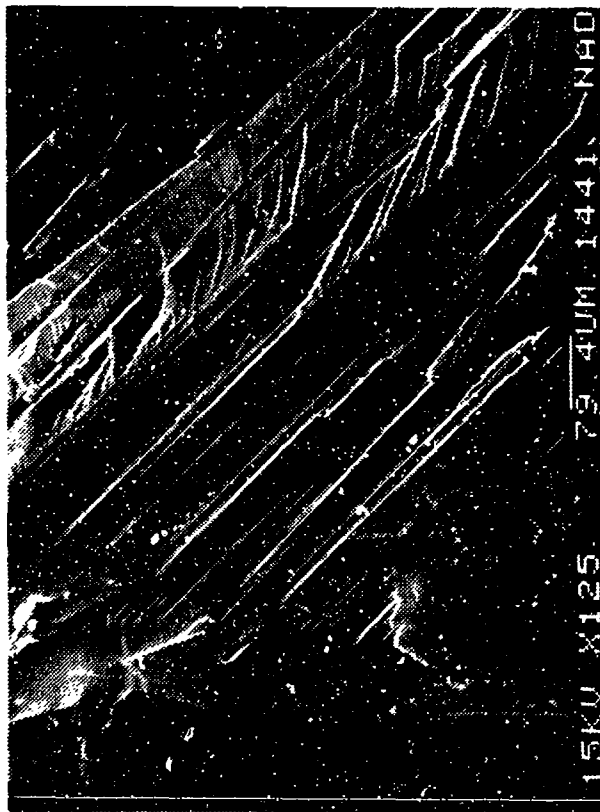
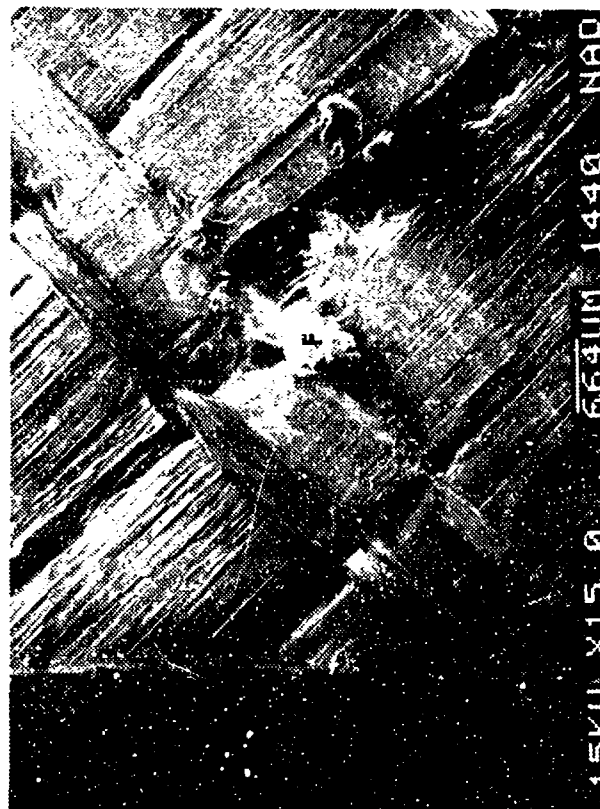
Figure 2-34. SEM Photographs of Mode I DCB Interlaminar Fracture in 3-D Weave Gr/Ep - [+45/-45]_{6s}

CD = Crack-propagation direction

F = Frayed carbon fibers used in weave

R = River patterns

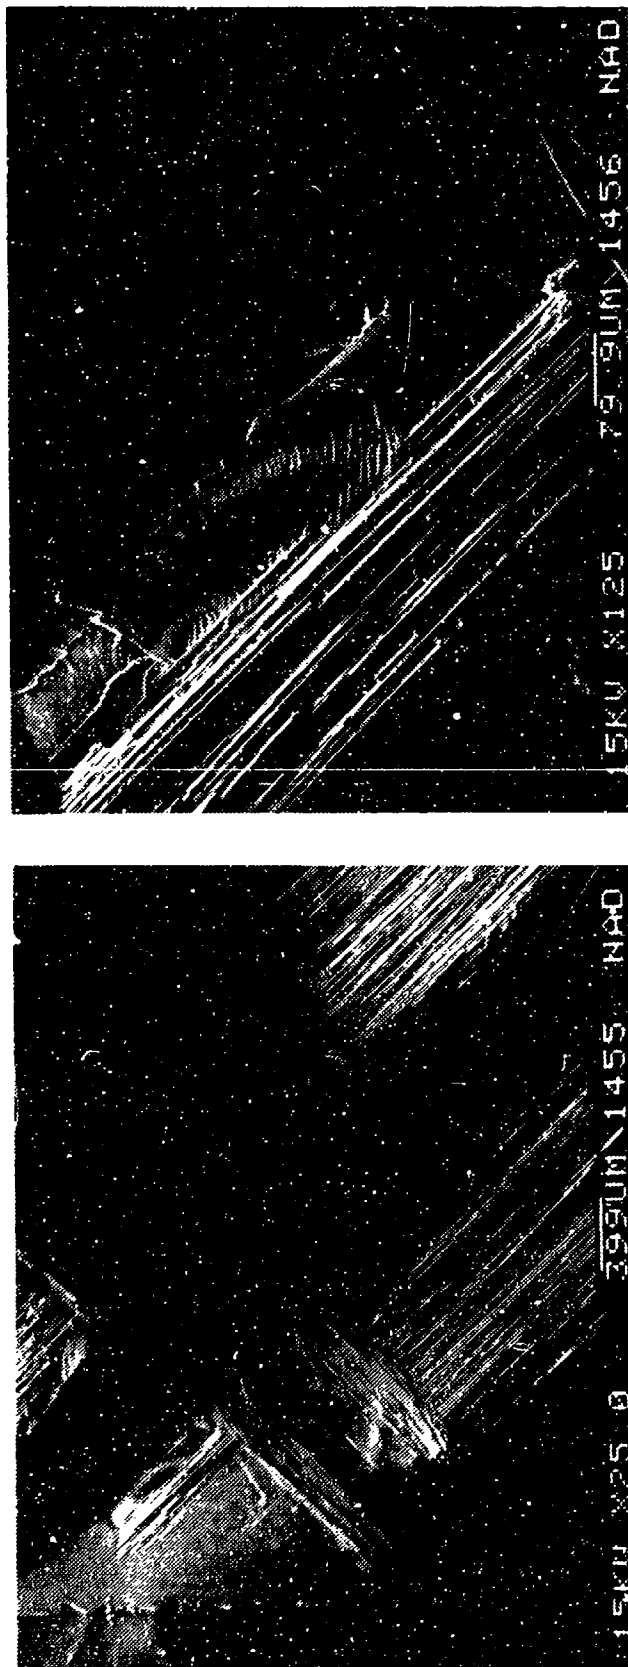
Figure 2-35. SEM Photographs of Mode I DCB Interlaminar Fracture in 3-D Weave Gr/Ep - [+45/0/-45]_{4s}
 (a) Initiation in Precrack Region of Coupon
 (b) River Patterns in Precrack Region

CD = Crack propagation direction
 R = River patterns

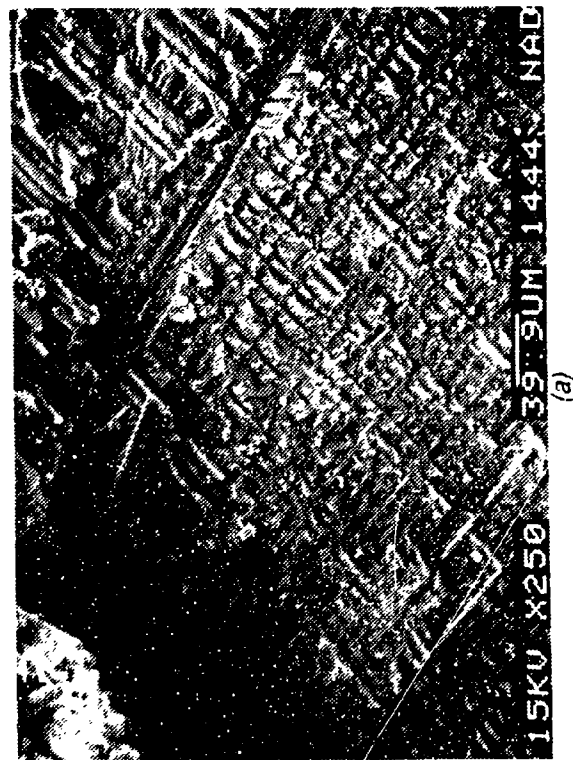
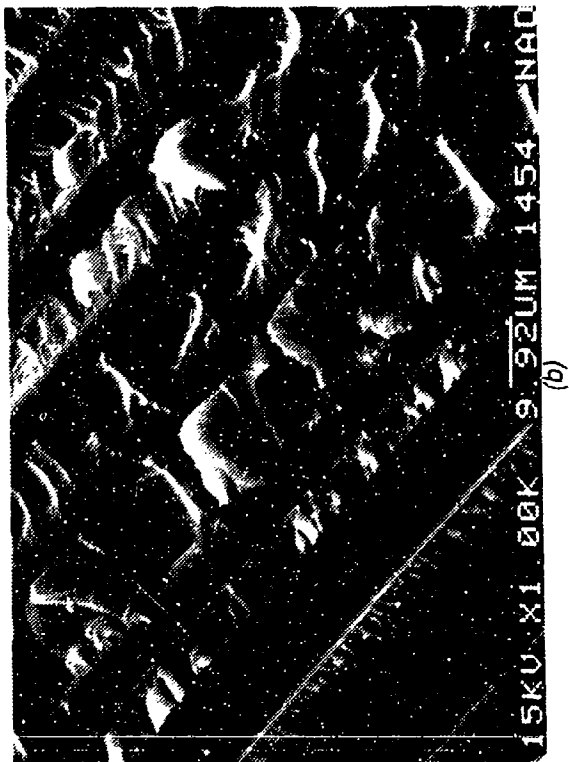
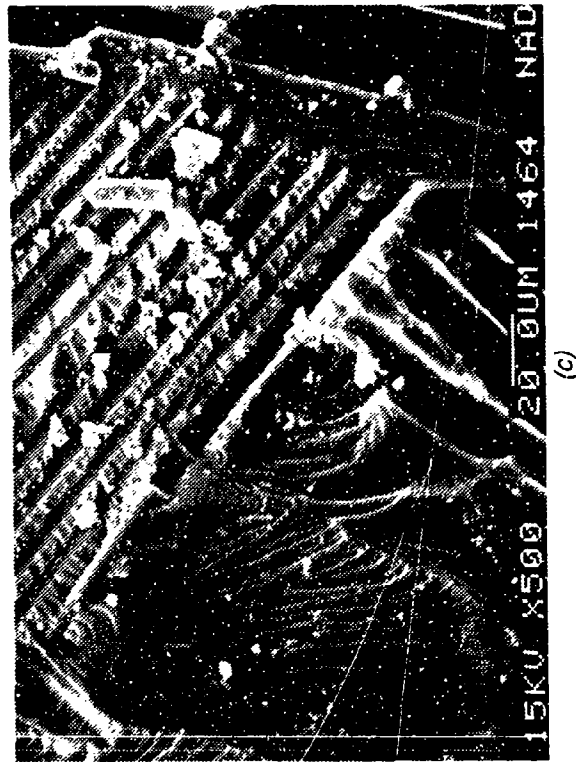
Figure 2-36. SEM Photographs of Mode I DCB Interlaminar Fracture in 3-D Weave Grl/Ep
 (a) Crack-Growth Region in $[+45/-45]_{ss}$
 (b) Higher Magnification of (a) Showing Hackles
 (c) Fractured Resin Pocket and Hackles in Crack-Growth Region of $[+45/0/-45]_{4s}$

CD = Crack-propagation direction
 F = Frayed carbon fibers
 H = Hackles
 P = Resin pocket
 R = River patterns

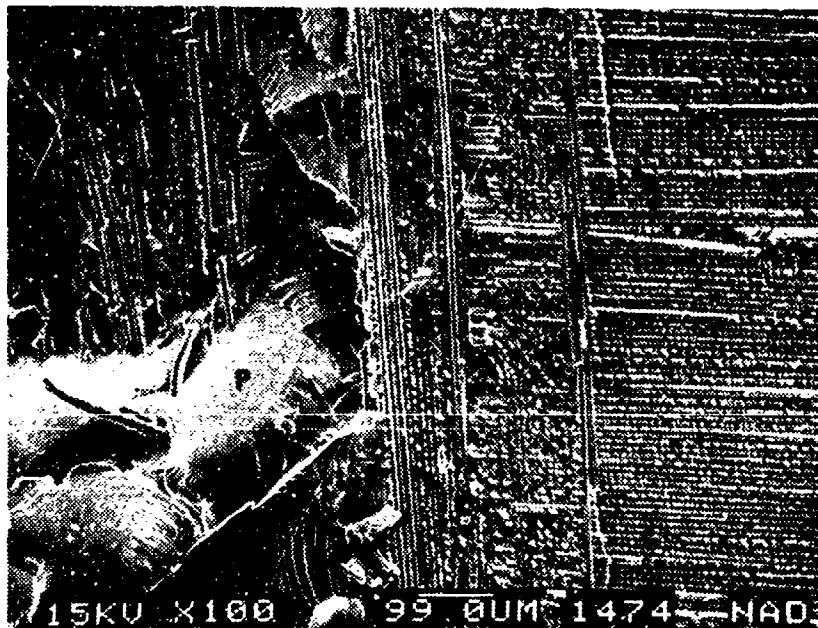
**Figure 2-37. SEM Photographs of Mode I DCB Fracture in 3-D Weave
 Gr/Ep - $[0/90]_{6S}$ in Crack-Growth Region**
 CD = Crack-propagation direction
 P = Resin pocket adjacent to carbon fiber used in weave

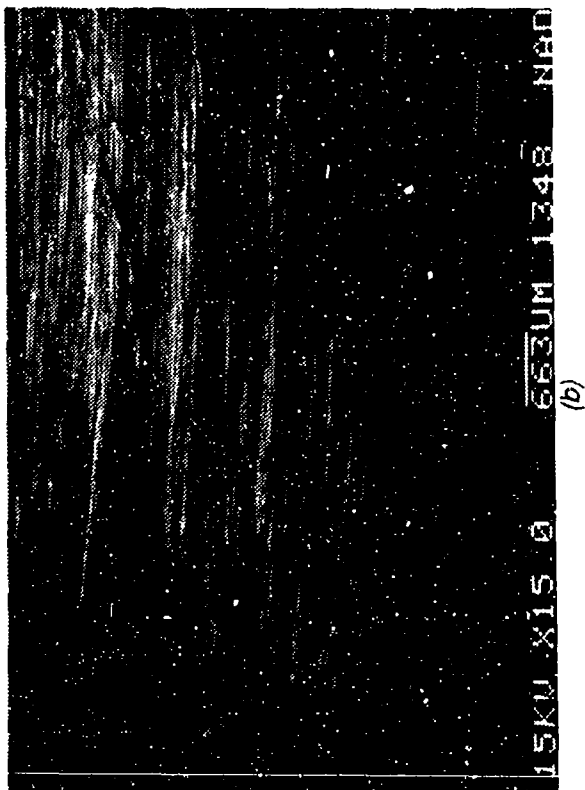
Figure 2-38. Optical and SEM Photographs of Mode I DCB Interlaminar Fracture in $\text{Gr/Ep} - [0]_{24T}$, Impact Damaged Before Test
 (a) Macrophotograph
 (b) Initiation in Precrack
 (c) River Patterns (R) in Mode I Region
 CD = Crack-propagation direction

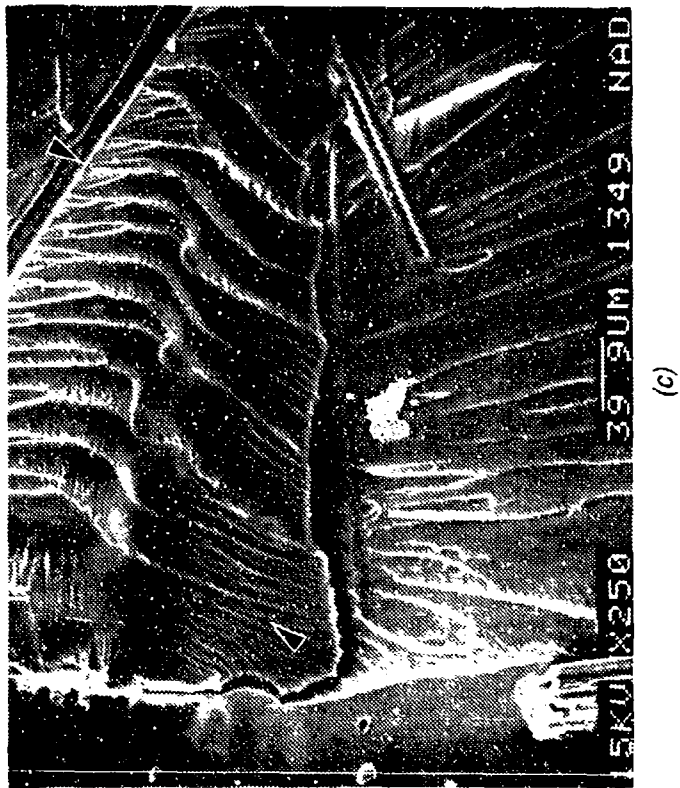
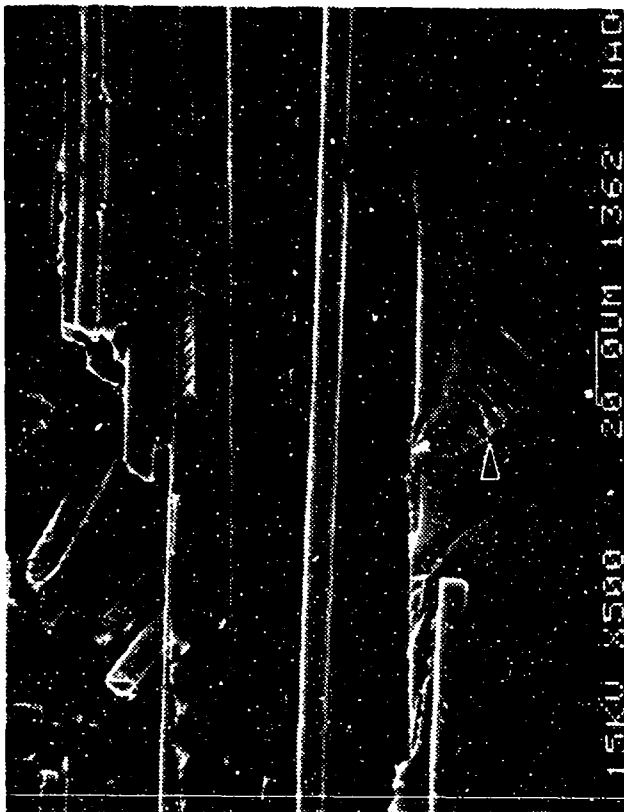
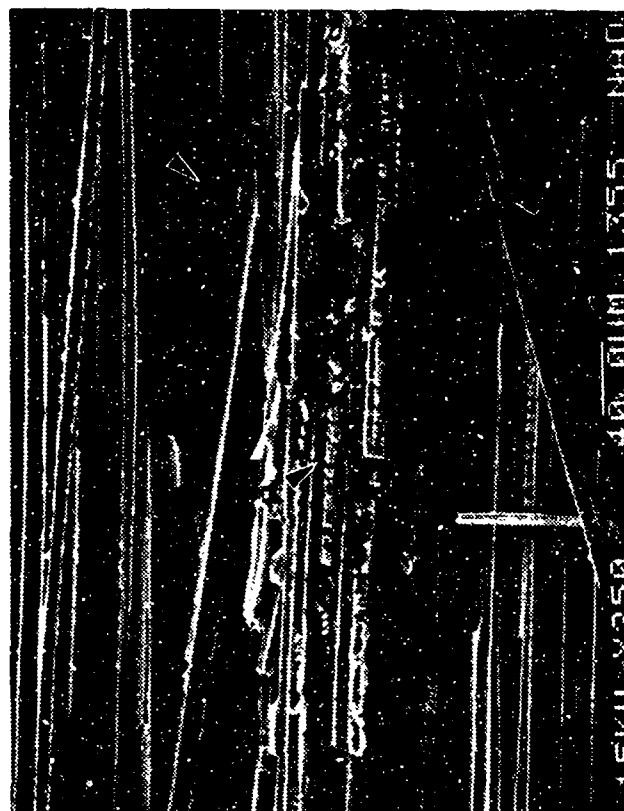
Figure 2-38. (Continued)
 (d) Impact Center
 (e) Broken Fibers in Impact Area
 Note river patterns in resin
 CD = Crack-propagation direction
 H = Hackles (cusps)
 R = River patterns

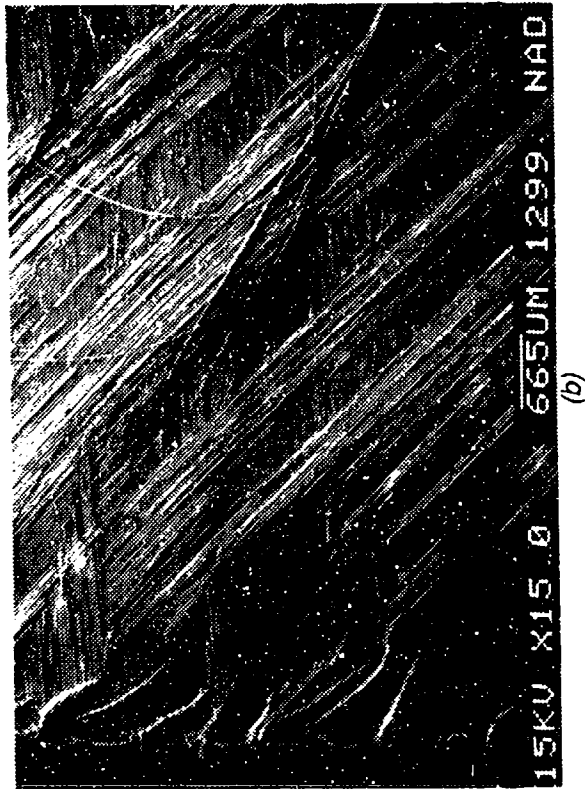
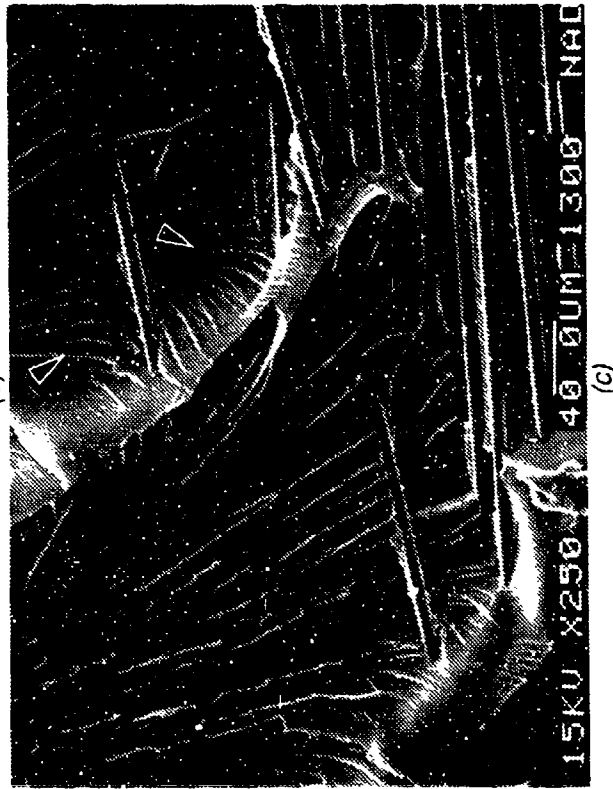
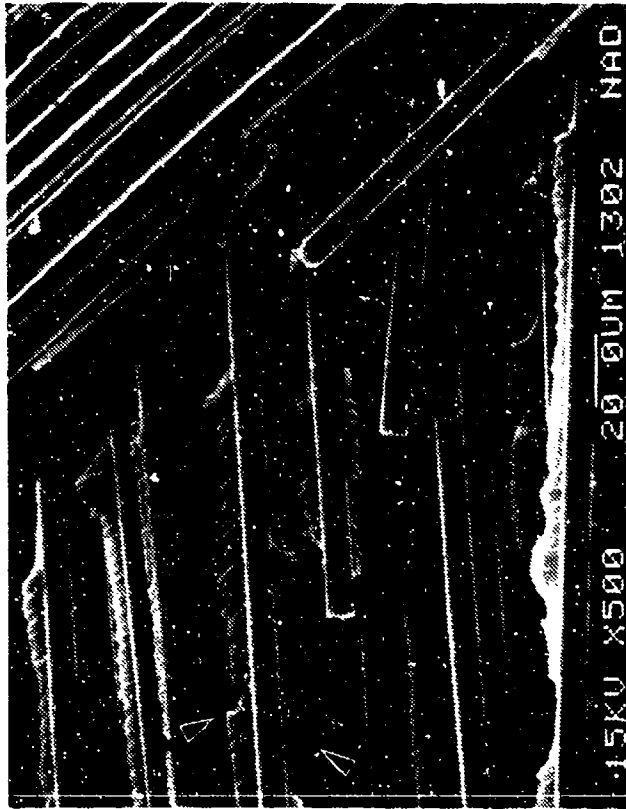
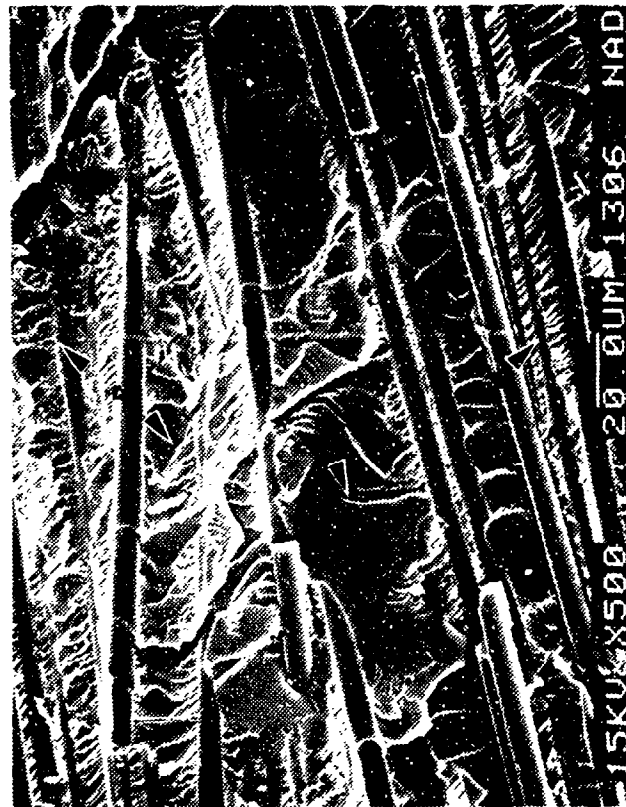
Figure 2-39. (Continued)
 (d) Impact Center
 (e) Interlaminar Fracture Away From Impact

CD = Crack propagation direction
 H = Hackles (cusps)
 R = River patterns

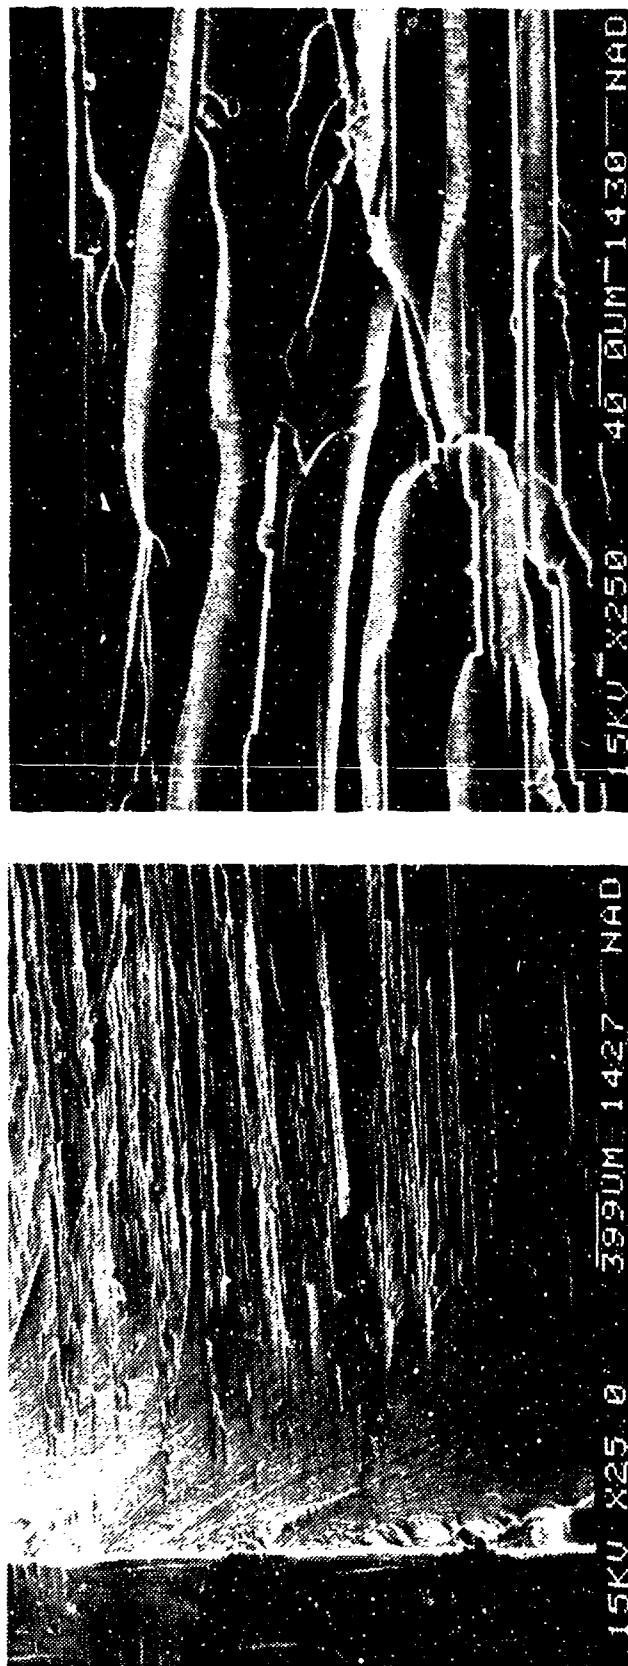
Figure 2-40. SEM Photographs of Mode I DCB Interlaminar Fracture in Gr/Ep - [0]_{24T}, Water Immersed Before Test

(b) River Patterns in Crack-Growth Region

CD = Crack-propagation direction

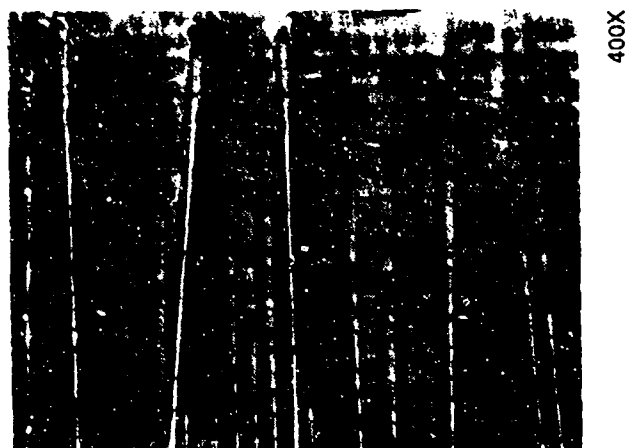
Figure 2-41. Optical Photomicrographs of Interlaminar Mode I Tension, 0/90 Fracture, Water Immersed (160 F) After Test

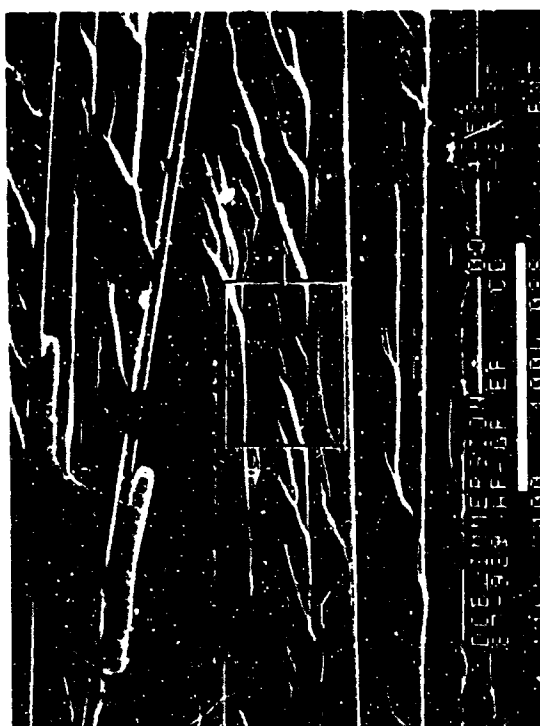
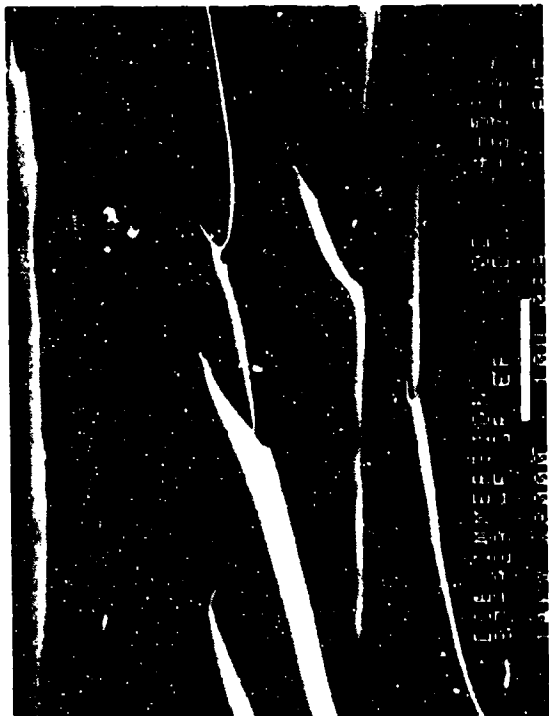
- M matrix fracture
- F fiber matrix separation
- R rivermarks

Mechanically induced
crack direction

Figure 2-42. SEM Fractographs of Interlaminar Mode I Tension, 0/90 Fracture, Water Immersed (160 F) After Test
